Reliability Analysis of LiDAR Sensor for Automotive Applications

Key words : LiDAR, Failure analysis, Reliability, Environmental test, Process improvement

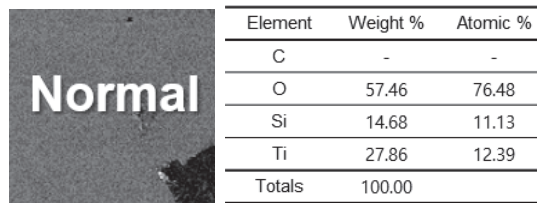
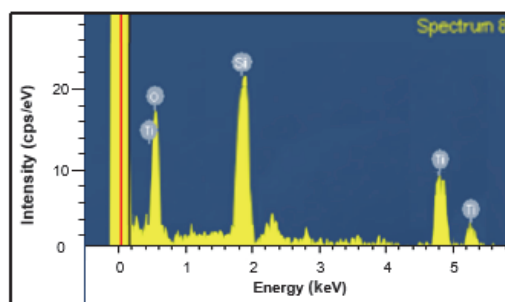
Fig. 7 EDS analysis results of the normal area of salt spray sample

As a result of the EDS component analysis, depicted in Fig. 7's normal area, the main components of the coating layer, Ti and Si, were detected, indicating that the coating is normally coated. Fig. 8, the failure area, is where the main

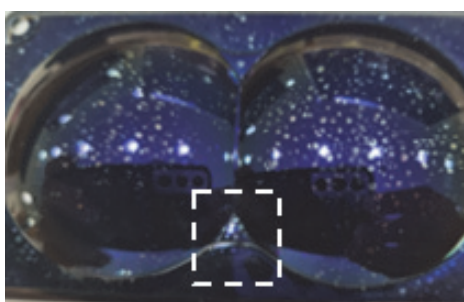
Fig. 5 Salt spray test sample

Experiments were conducted in which LiDARs were attached to real-world vehicles and exposed to a coastal environment with high salinity and humidity, and coating delamination was observed to occur on the LiDAR covers. The delamination phenomenon was successfully reproduced, as represented in Fig. 5, using a salt spray test(ISO 16750-4, Environmental conditions and tests for vehicle electrical and electronic components), which is a representative environmental test that can reflect the coastal road environment.^{10,11)}

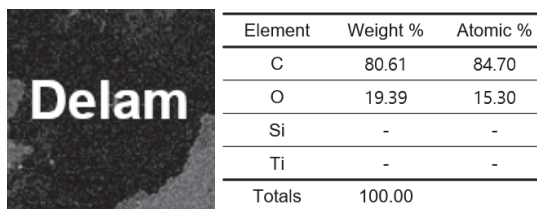
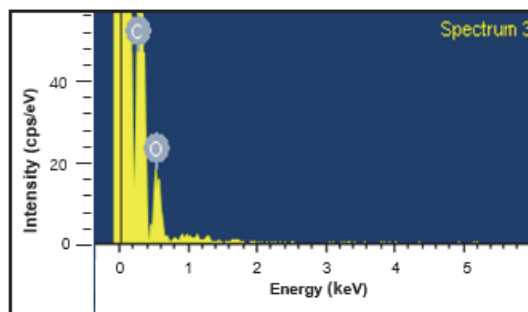
Fig. 8 EDS analysis results of the delamination area of salt spray sample

components of the coating layer, such as Ti and Si, were not detected, and the lower cover layer components were detected, confirming that the coating was delaminated.

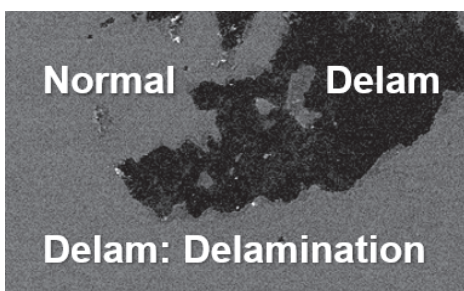
Fig. 6 SEM analysis results of the salt spray test sample

Fig. 6 displays the results of the scanning electron microscope(SEM) analysis of the failure sample, which confirmed the delamination phenomenon divided into a normal area and a delaminated area. A compositional analysis of these areas is conducted to determine the material cause of the failure.

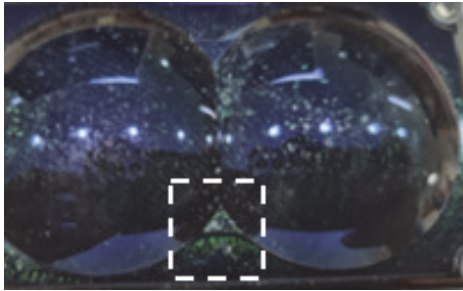
Fig. 9 Field failure LiDAR sample

Fig. 9 demonstrates the front view of the actual field failure part LiDAR cover, and Fig. 10 details the SEM analysis result of the actual field failure part. As in the salt spray test above, the normal area and delamination area

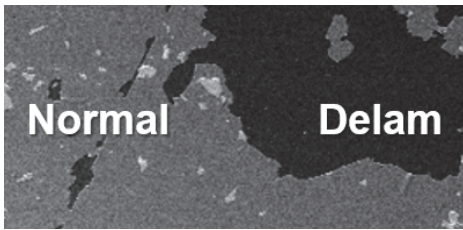
Fig. 10 SEM analysis results of the field failure sample

were distinguished.

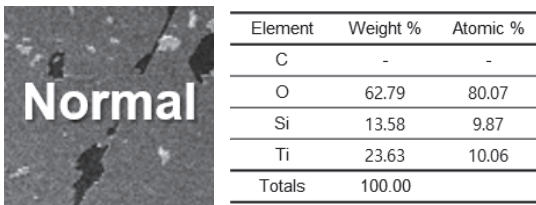
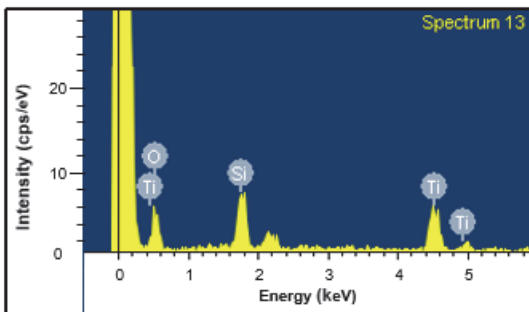
Fig. 11 EDS analysis results of the normal area of field failure sample

After the EDS component analysis of the area, it was confirmed that the coating was applied uniformly as Ti and Si components were detected in the normal area in Fig. 11, but the main components of the coating, such as Ti and Si, were not detected in the failure area in Fig. 12. Hence, it was determined that the uneven coating application caused the delamination. It also suggests that the salt spray test successfully reproduces the field failure phenomenon.

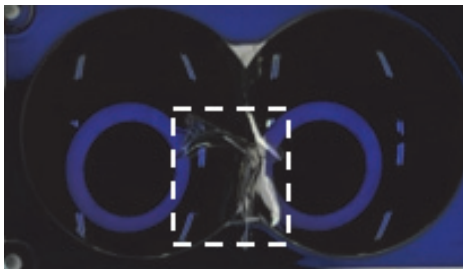
Fig. 13 High temperature and humidity test sample

In addition to salt spray, several environmental factors were evaluated. Since LiDARs are composed of a multilayer structure of covers and coatings, as demonstrated in Fig. 4, which can lead to failure due to mismatched coefficients of thermal expansion when subjected to temperature, an environmental test under high temperature and humidity conditions was conducted (Environmental conditions and tests for vehicle electrical and electronic components, ISO 16750-4).¹²⁾ Consequently, it was confirmed that the delamination phenomenon of the coating surface was reproduced in the high temperature and humidity sample on the front of the LiDAR cover, as can be gleaned from Fig. 13. The Focused ion beam (FIB) destructive analysis in Fig.

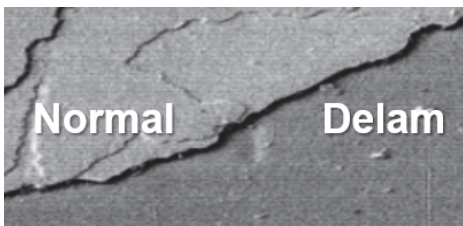
Fig. 14 FIB analysis results of the high temperature and humidity test sample

14 confirmed the distinction between the delamination area and the normal area, and the component analysis in Fig. 15 verified the detection of Ti and Si, the main components of the coating, in the normal area, while Ti and Si were detected in very small amounts in the delamination area, as

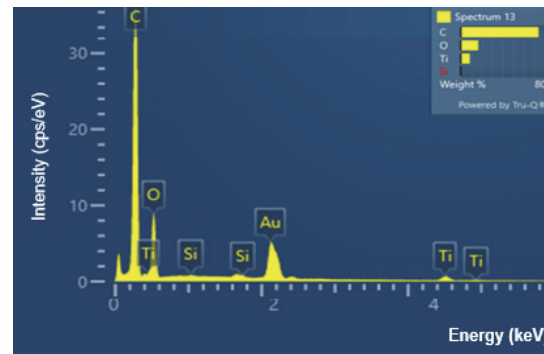
Fig. 16 EDS analysis results of the delamination area of high temperature and humidity test sample

seen in Fig. 16. This confirmed that the delamination was caused by the high temperature and humidity test conditions.

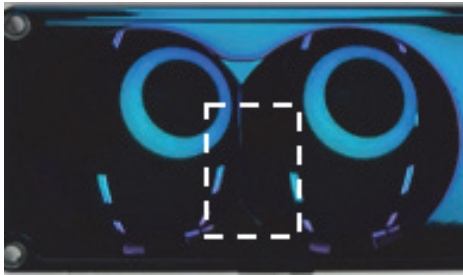
Fig. 17 Improved LiDAR after high temperature and humidity test sample

In conclusion, due to the uneven surface coating, the surface area was exposed to environmental factors, such as salt water, high temperature, and high humidity, which caused surface delamination and led to failure. Based on the comprehensive results of this study's real vehicle environment-based reliability environmental test, structural analysis, and component analysis, the LiDAR cover coating process was improved by optimizing the gas composition ratio, temperature and pressure conditions, and subsequent curing in the deposition chamber. The front part of the LiDAR cover with the improved coating material as shown in Fig. 17 was not subjected to appearance failure in the salt spray tests and high temperature and humidity tests under the same conditions as before. In addition, EDS component analysis using high-resolution FIB confirmed the detection of Ti and Si, the main components of the coating. Therefore, it is verified, as reflected in Fig. 18, that the reliability of the coating was improved without delamination even after the environmental test.
