Reliability Analysis of LiDAR Sensor for Automotive Applications

Key words : LiDAR, Failure analysis, Reliability, Environmental test, Process improvement

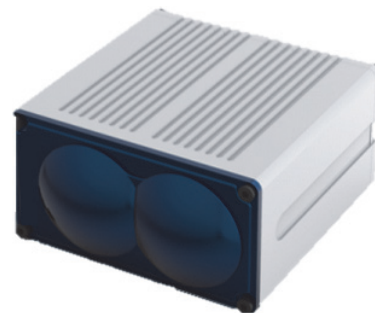
Fig. 3 The exterior of a LiDAR

Fig. 3 presents the exterior image of the LiDAR. This study focuses on the failure of the front part of the LiDAR cover before and after reliability evaluation. Fig. 4 illustrates
